US-54 Central Business District Viaduct

KDOT Project No. 54-87 KA-1647-02

BRIDGE REHABILITATION

KANSAS STATE UNIVERSITY BRIDGE DESIGN WORKSHOP

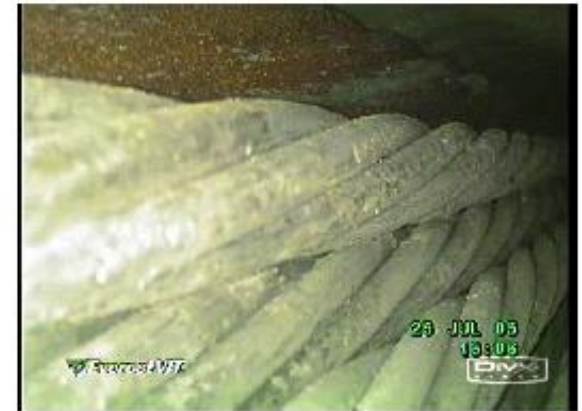
Span 9
Westbound
Draped Web
Tendon 21

Corrosion on Duct

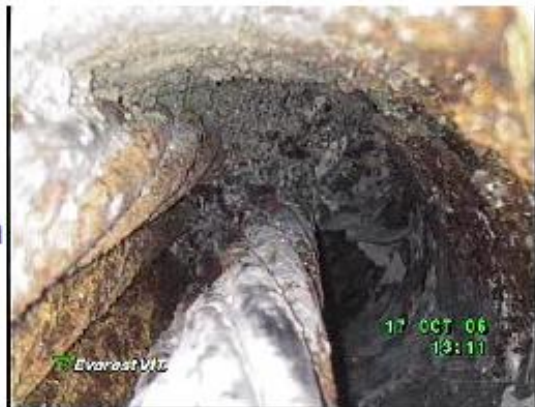
Pier 14
Westbound
Vertical Tendon
8

View of Void Bottom
Corrosion on Duct and Tendons

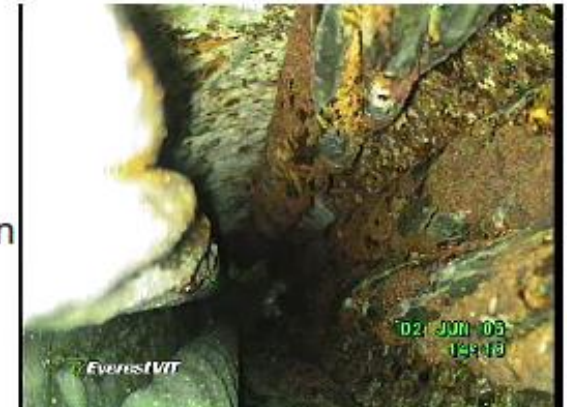
Pier 14
Eastbound
Vertical Tendon
5

Corrosion on Both Duct and Tendon

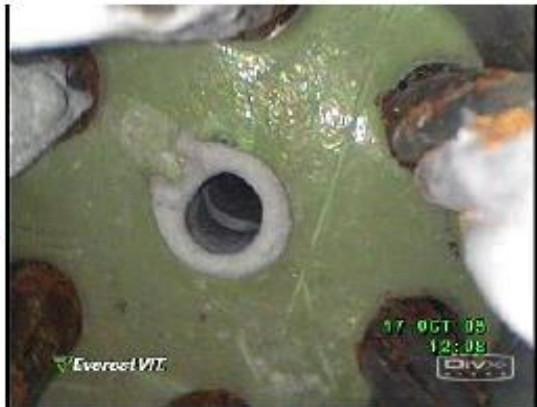
Pier 14
Westbound
Vertical Tendon
2

Close-up of Anchor. Top of
Tendons Show some Corrosion

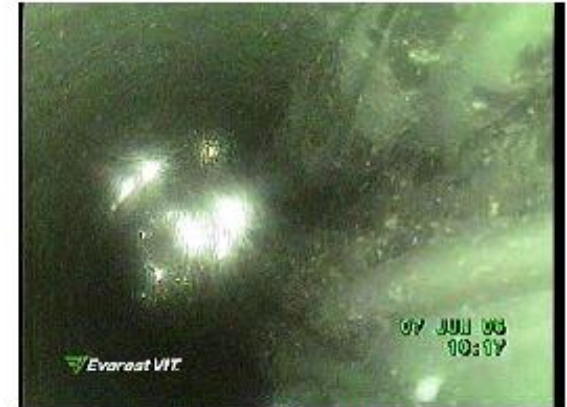
Pier 14
Center Web
Vertical 3

Tendon Found with Standing
Water inside

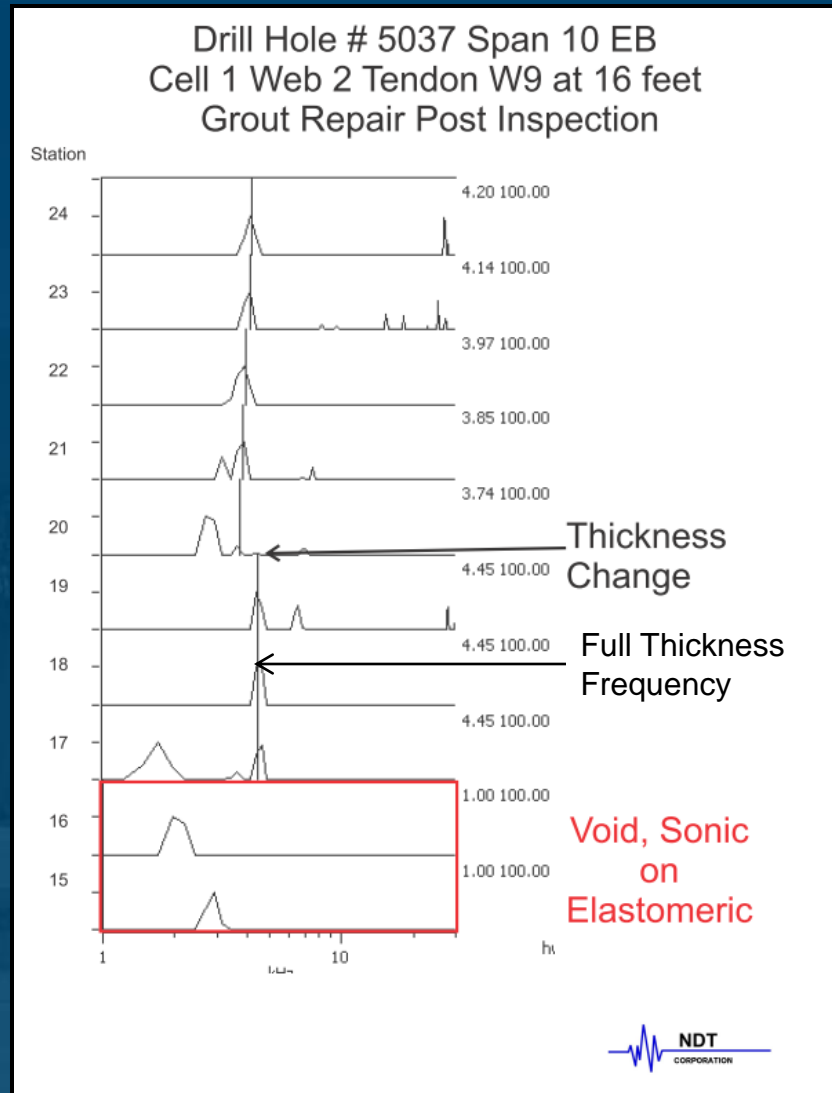
Void Found

Re-grouted 8/20/2014
by vacuum grouting

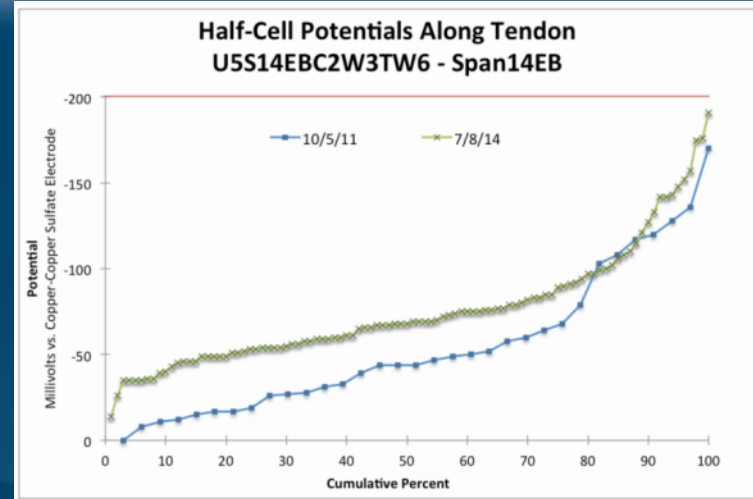
Figure 2 (Voids with soft/wet grout in 2010 but dry at STA 110 in 2011)

- More positive than -200 mV: 90% probability of no corrosion
 - Range of -200 and -350 mV: Corrosion is uncertain
 - More negative than -350 mV: 90% probability of corrosion
- (Note: Potentials versus copper copper-sulfate electrode)
