US-54 Central Business District Viaduct

KDOT Project No. 54-87 KA-1647-02

BRIDGE REHABILITATION

KANSAS STATE UNIVERSITY BRIDGE DESIGN WORKSHOP

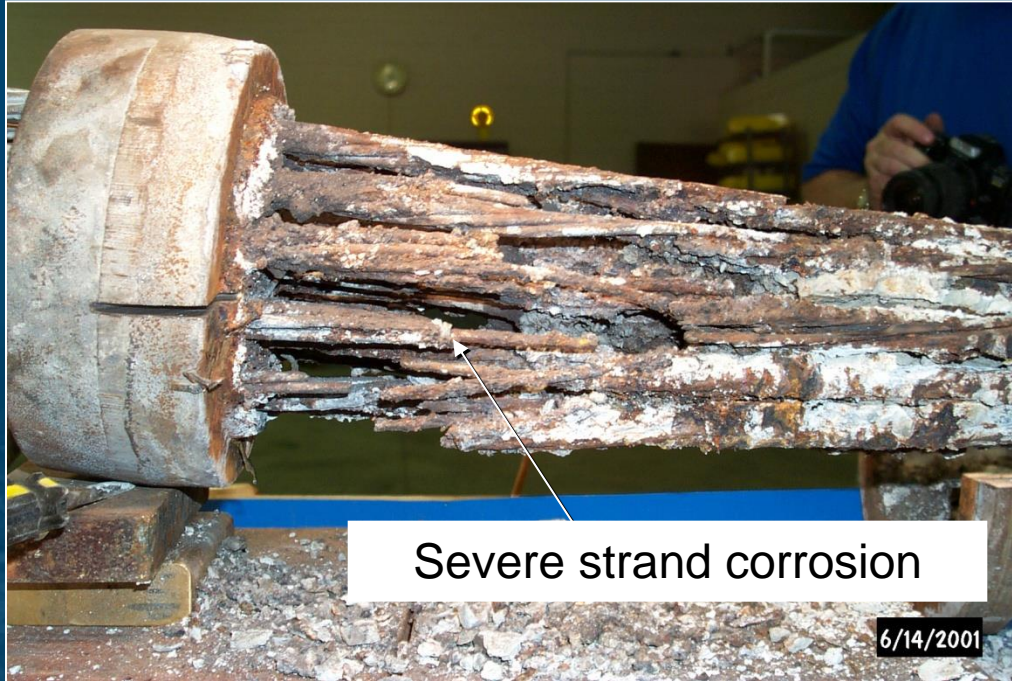
Sunshine Skyway Bridge, FL

Severe strand corrosion

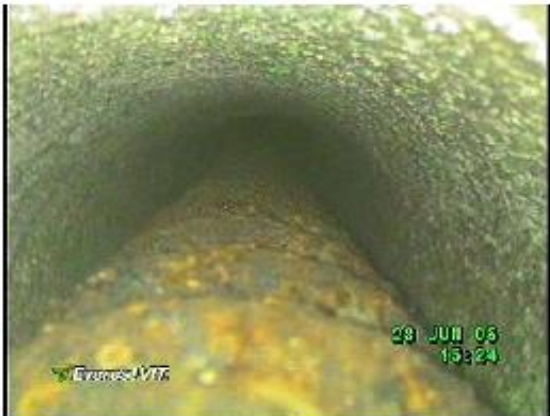
Pier 13
Center Web
Vertical Tendon
3

Void in Pier With Dywidag Bar
Instead of Tendons

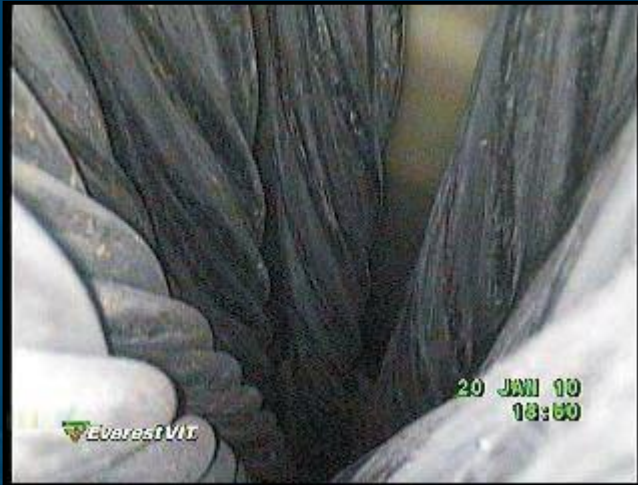
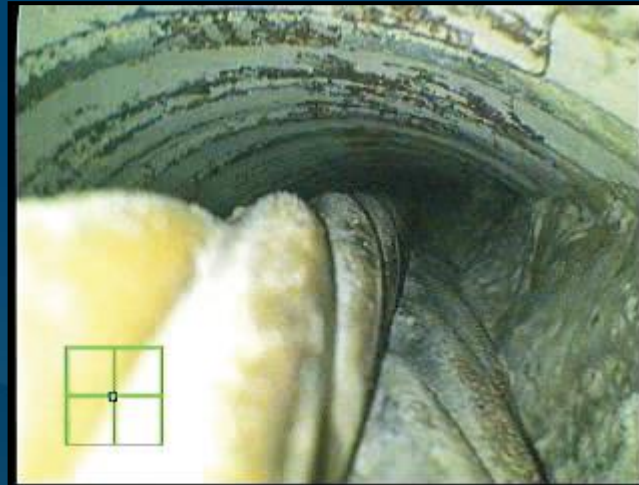
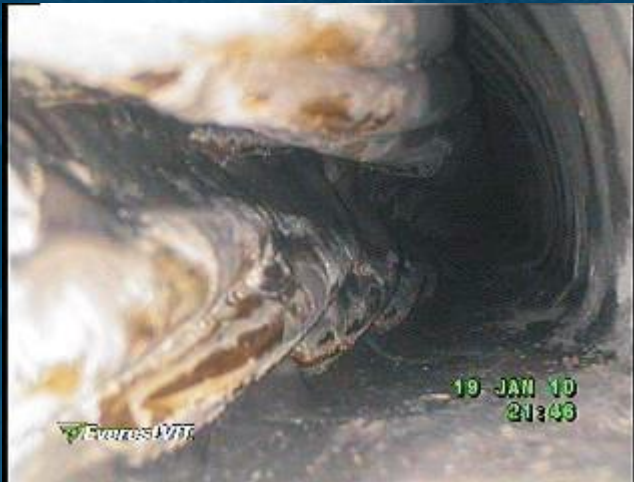
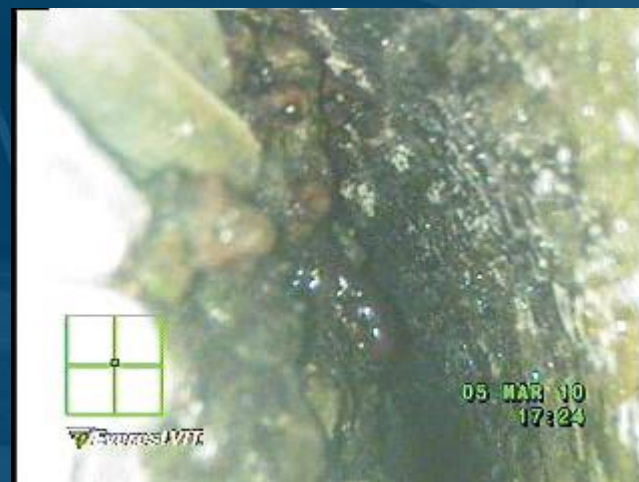
Video Borescope Inspection of Ducts

- Void verification by drilled holes identified by sonic testing
- Boroscope used to find limits of void

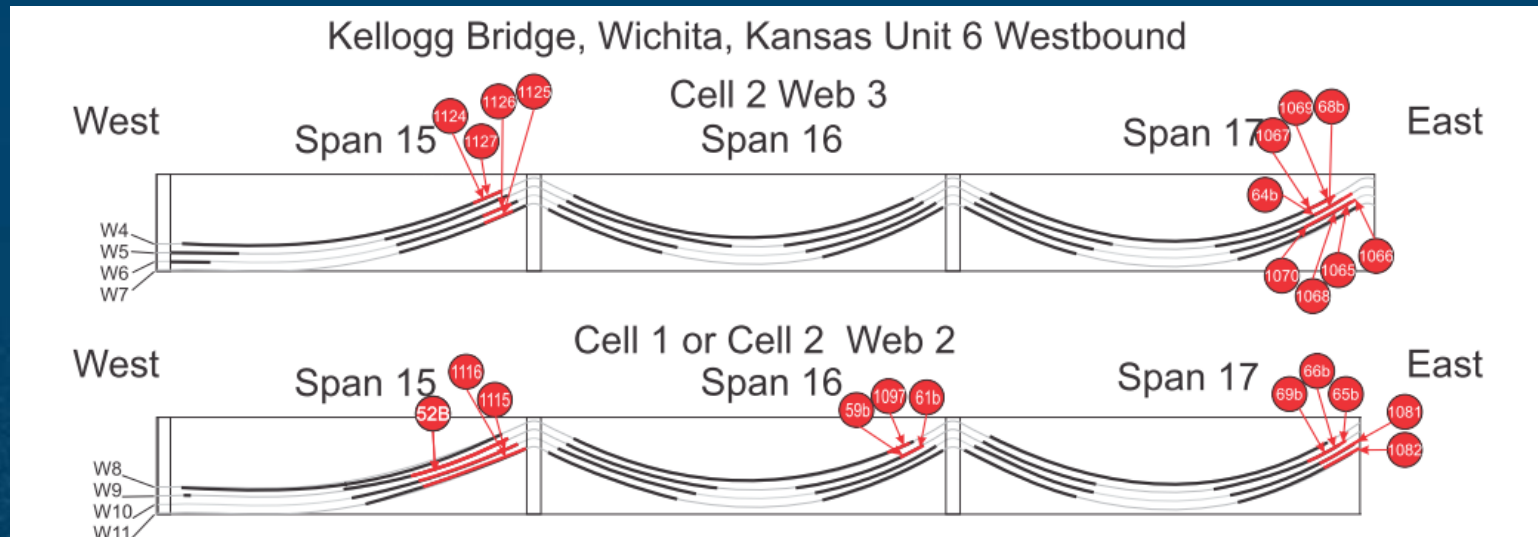
Web Post-tensioned Ducts

- ◆ Draped Web tendons: **46%** of tendons inspected have voids
- ◆ Longitudinal Top tendons: **6%** of tendons inspected have voids
- ◆ Diaphragm Transverse Tendons: **25%** tendons inspected have voids
- ◆ Transverse Deck Tendons: **5%** tendons inspected have voids
- ◆ Hinge Tendon: **5%** of tendons inspected have voids
- ◆ Soft grout in the duct at six locations
- ◆ Water in the duct at multiple locations; some voids dry
- ◆ Low rates of corrosion at present

Inspection Findings

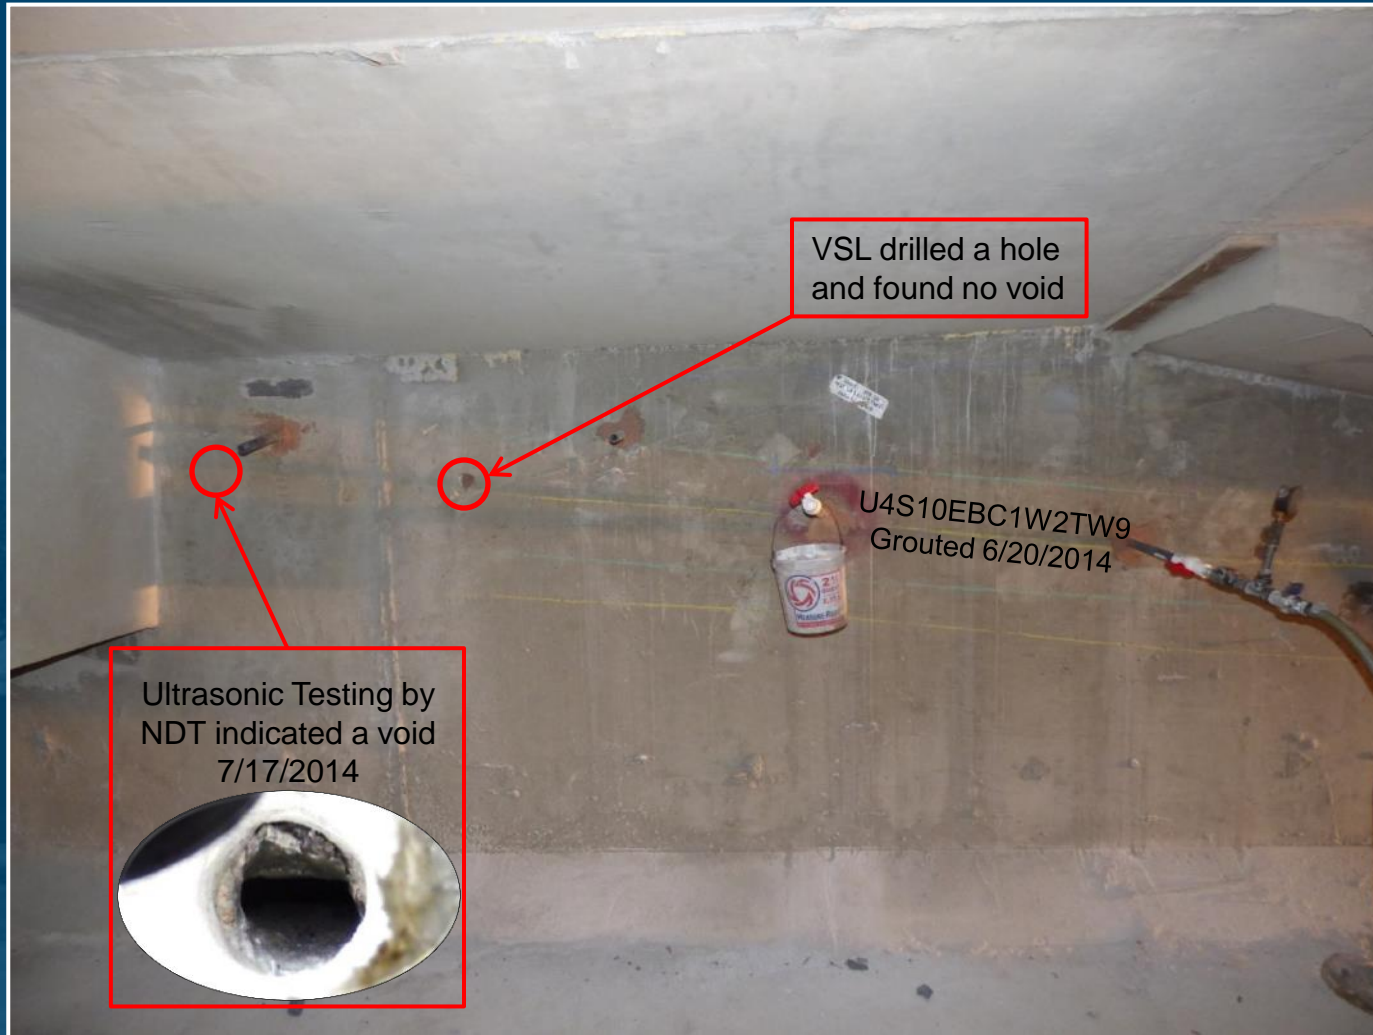
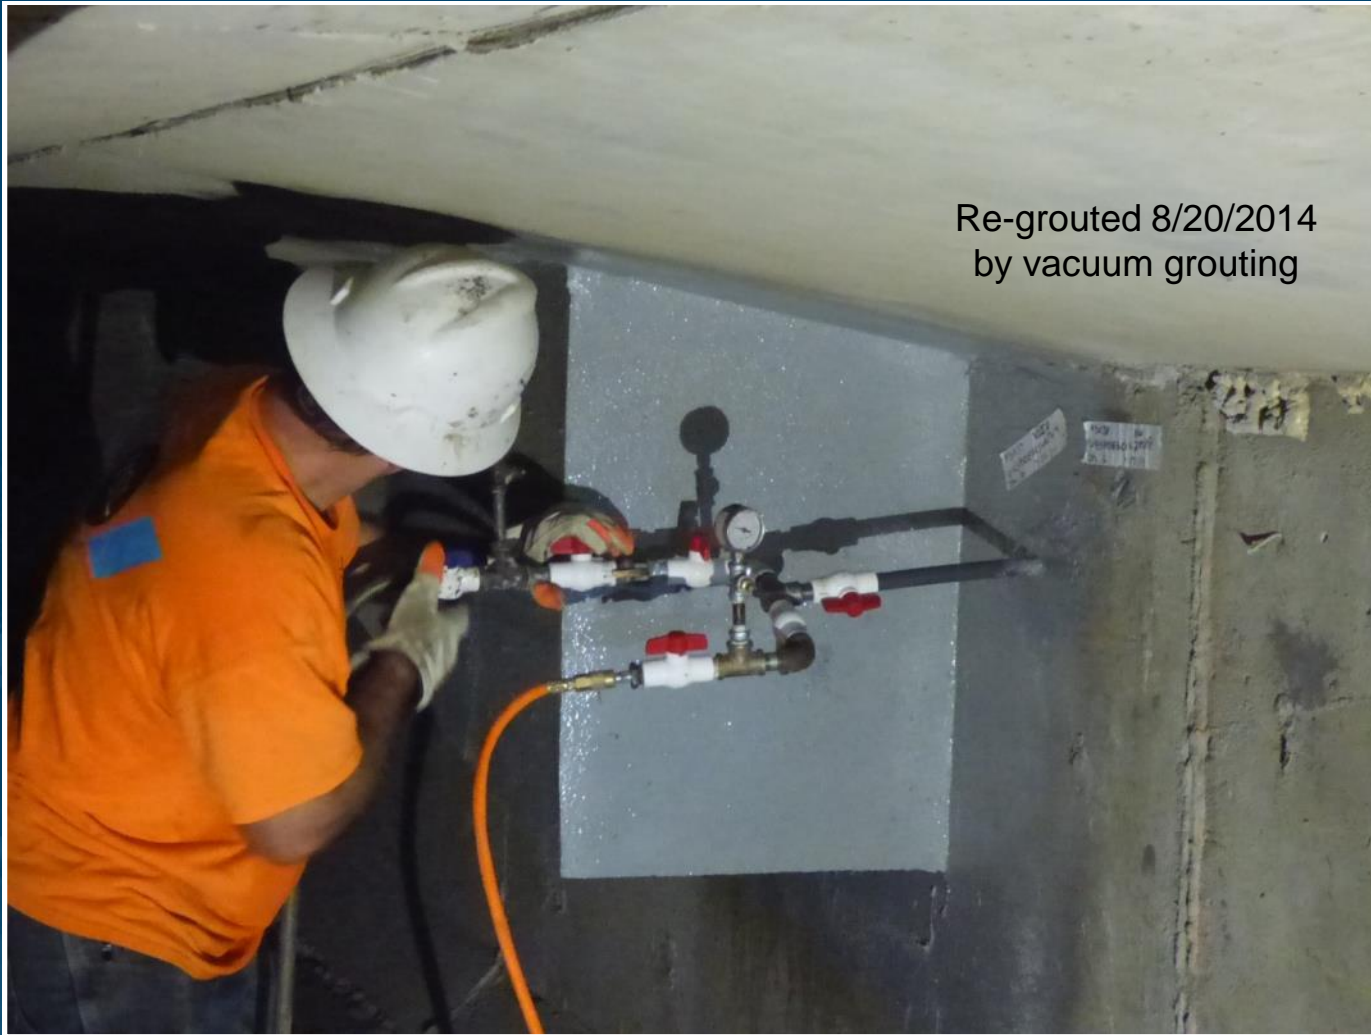
Void Found

Re-grouted 8/20/2014
by vacuum grouting

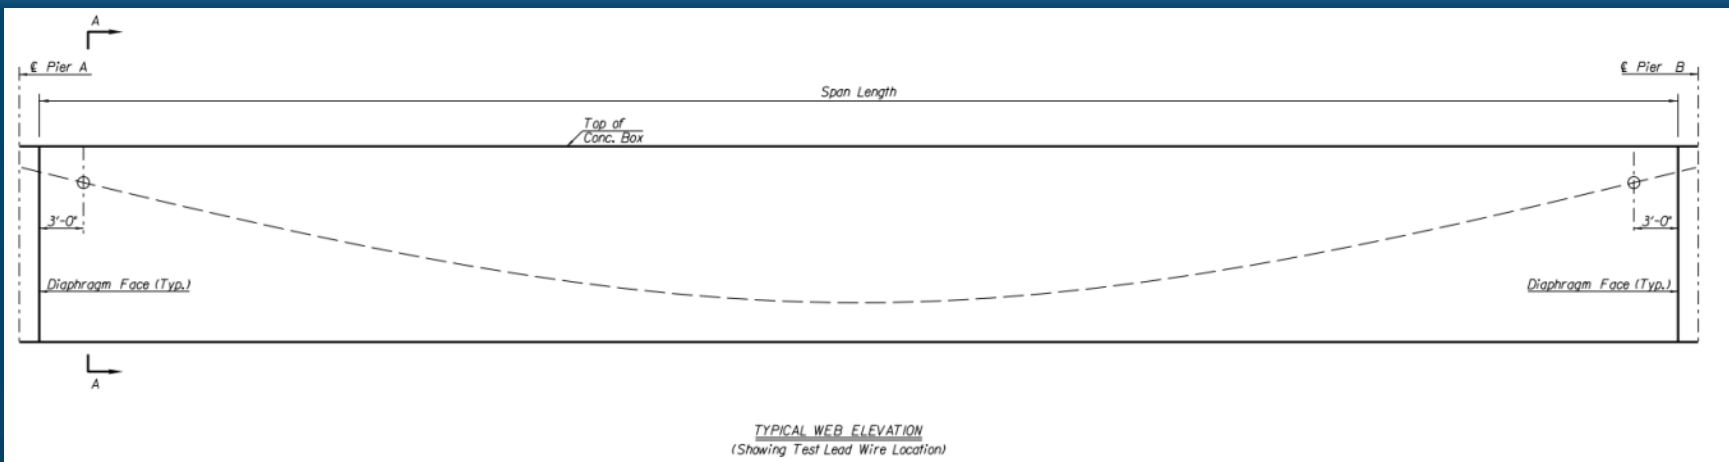
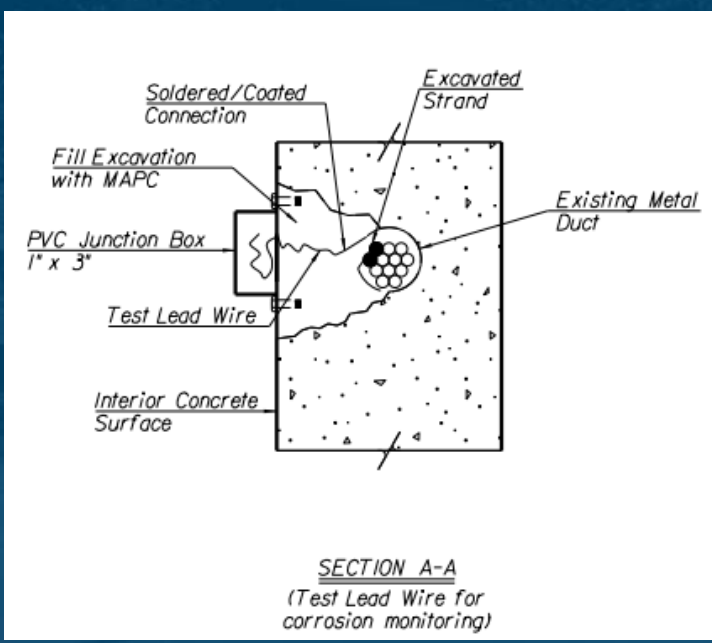
* The listed tendons contain Soft Grout and will be monitored for potential corrosion as shown on this sheet. See elevation view for location of test lead wires.

UNIT NO.	SPAN NO.	DIR.	CELL NO.	WEB NO.	TEND. NO.	DEFICIENCY
6	16	WB	1	1	W5	Water

This Tendon shall be drained and re-grouted as per project plan notes.

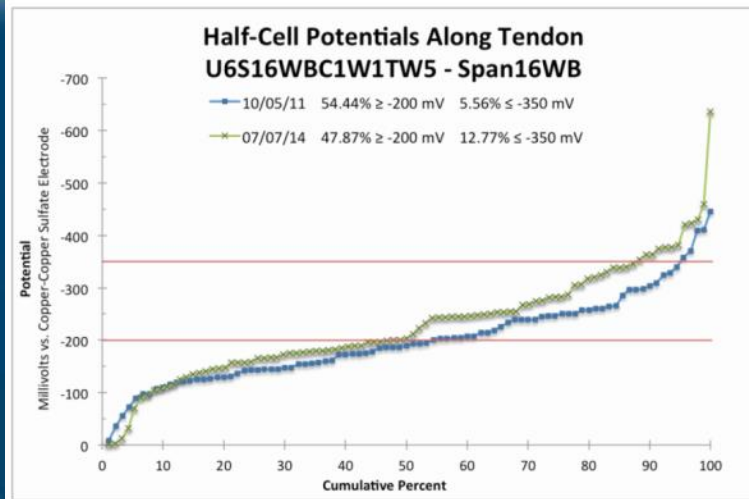
Figure 1 (Void with water 2011)

- More positive than -200 mV: 90% probability of no corrosion
 - Range of -200 and -350 mV: Corrosion is uncertain
 - More negative than -350 mV: 90% probability of corrosion
- (Note: Potentials versus copper copper-sulfate electrode)

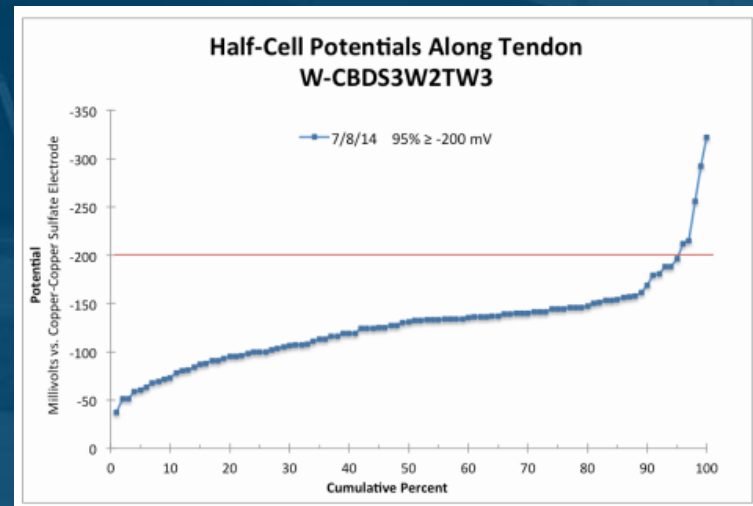
Figure 7 (Void with soft/wet grout and/or accumulated water 2011)
